Test Report

Fire Resistance test of singly glazed windows covered by screens of aluminized fabric tested in general accordance with AS 1530.8.1-2007

2258400

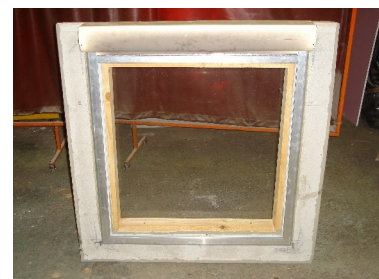
Description Single glazed window comprising of 6 mm thick float glass, 900 mm by 900 mm, held in place by timber nominally 100 mm by 28 mm on each face, screw fixed around the edge of the glass.

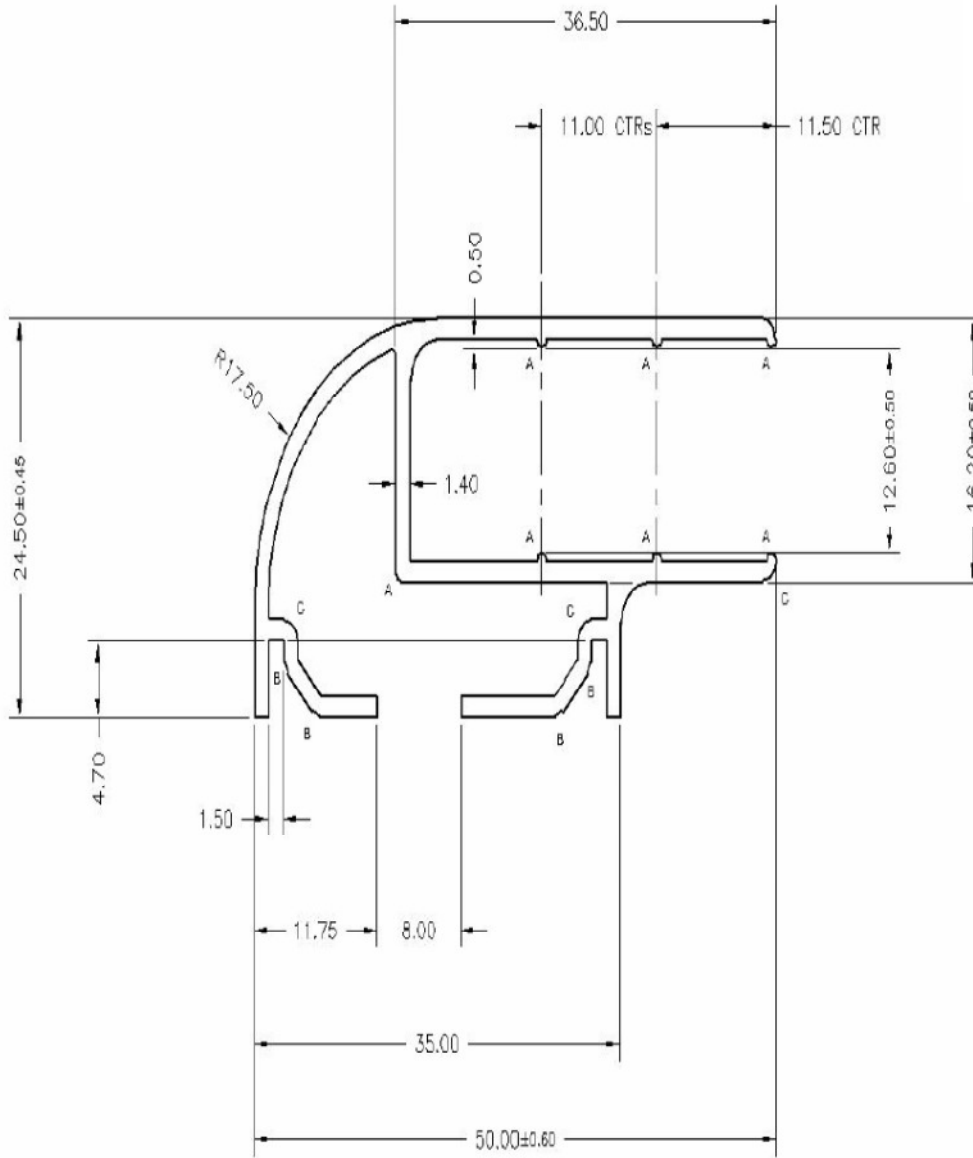
Figure A1.1: Edging Channel (Drawing provided by test sponsor.)

ITEM	DESCRIPTION
Product Name	Wildfire Heat Protective Shield
Screen size	Nominally 970 mm high × 920 mm wide × 1 mm thick.
Screen Composition	A single layer of Wildfire Protection Layer sandwiched between layers of Wildfire Aluminized Fabric #40 on each side. (Alternative trade names held on file.) Horizontal strengthening rods of 6 mm diameter steel were sewn into the screen at nominally 440 mm and 860 mm above the bottom edge of the screen. The screen bottom bar was fixed at each end with right angled steel locking pins, 230 mm by 6 mm, which engaged an aluminium tube of rectangular cross section, 40 mm by 10 mm.
Edging channels	Aluminium extruded edging channels, 50 mm wide and 35.1 mm deep, were fitted to the exposed face along the vertical sides and along the bottom edge of the window. Each channel had a slot along the back face which engaged with screws fixed through the cement sheet to the timber surround. The edges of each channel were sealed to the surface of the cement sheet using silicone sealant. The aluminized fabric screen was inserted into the track on each vertical side to a depth of 35 mm.

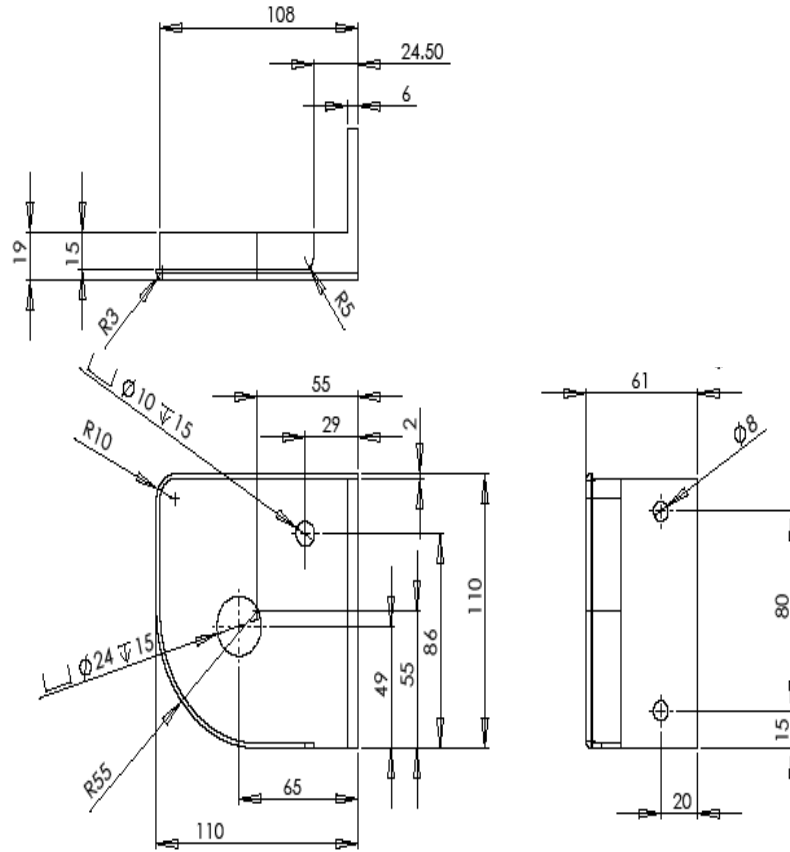
Figure A1.2: Pelmet Bracket (Drawing supplied by test sponsor.)

Pelmet	The screen was hung from an aluminium roller bar, 38 mm in diameter with a 14 mm diameter axle, supported at each end by aluminium end brackets approximately 110 mm by 110 mm, fixed to the exterior surface by 2-off screws passing through a fixing plate 50 mm wide and 10 mm thick. The screen passed over a guide roller nominally 16 mm in diameter. The roller bar and guide roller were covered by an aluminium cover, 0.64 mm thick, 960 mm long and approximately 110 mm by 110 mm in cross section. The back of the pelmet was screw fixed to an aluminium tube of square cross section, 40 mm by 10 mm along the back edge of the pelmet, fixed through the cement sheet to the timber surround by 3-off screws.

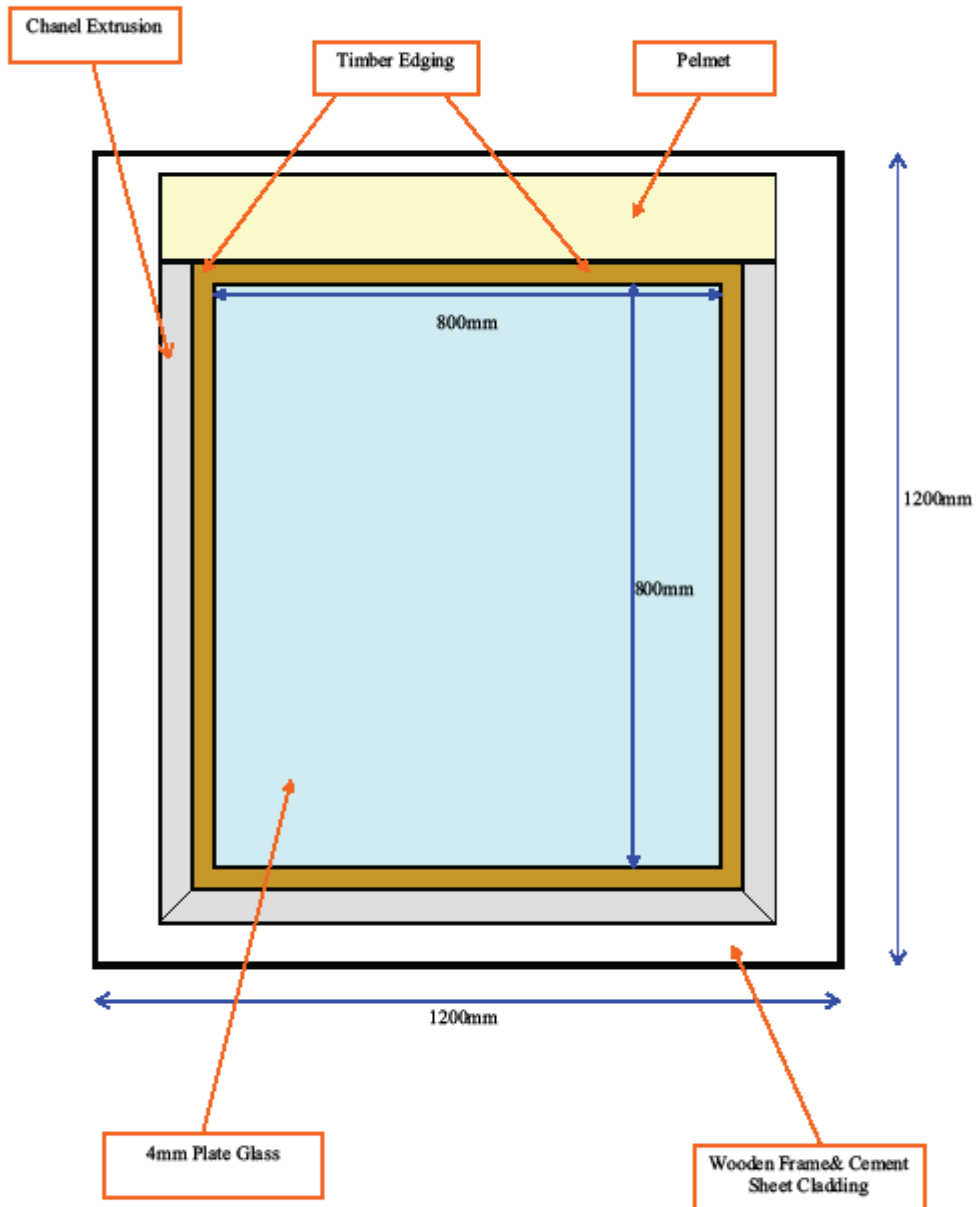
Figure A1.3: Assembly detail (Drawing supplied by test sponsor.)

The window was installed into the opening in the wall. The screen frame guides and pelmet were mounted over the exposed timber frame and cement sheet junction on the external side assembly. The aluminized screen was extended from the pelmet to cover the glazing. The screen bottom bar was fixed at each end with right angled steel locking pins. The system was constructed by representatives of the test applicant on 28th April 2008.

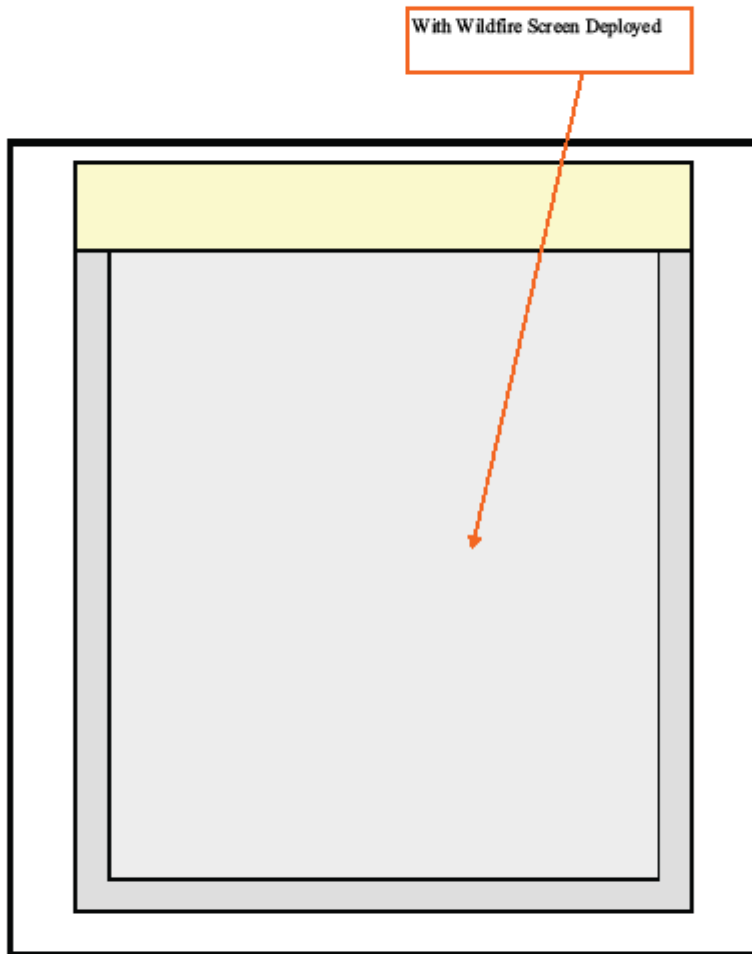
Figure A1.4: Assembly detail (Drawing supplied by test sponsor.)

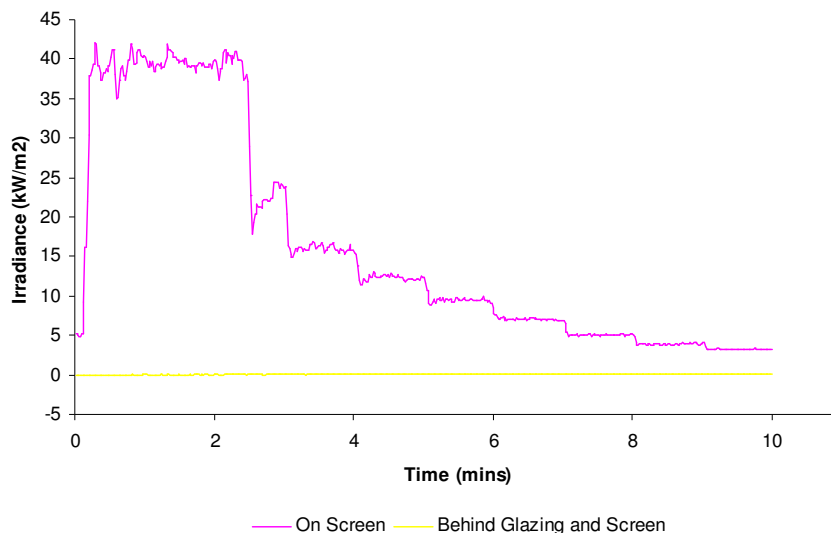
Figure A3.1. Radiant heat exposure profile and irradiance calculated for a distance of 365mm away from unexposed face of Specimen F.

The initial radiant heat profile for Specimen F was slightly below that required by the standard for short periods of time, the radiant heat flux was 35 kW m^{-2} as opposed to 40 kW m^{-2} for 30 seconds and 18 kW m^{-2} as opposed to 24 kW m^{-2} for 20 seconds. The average radiant heat flux for the two initial exposure periods was 40 kW m^{-2} and 24 kW m^{-2} respectively. Outside of the brief periods where the radiant heat was below that required by the standard the test specimen did not emit any volatiles which could be ignited and the transmitted irradiance through the screen was negligible throughout the whole testing period. Therefore it is considered that the lower irradiance levels did not affect the results of this test.

Performance Criteria	Time to Failure (min)	Position of Failure
Formation of through-gaps greater than 3 mm	No Failure	
Sustained flaming for 10 s on the non-fire side	No Failure	
Flaming on the fire-exposed side at the end of the 60 minute test period.	No Failure	
Radiant heat flux 365mm from the non-fire side exceeding 15 kW m ⁻²	No Failure	
Mean and maximum temperature rises greater than 140K and 180K	Not Applicable	
Radiant heat flux 250 mm from the specimen, greater than 3 kW m ⁻² between 20 min and 60 min	No Failure	
Mean and maximum temperature of internal faces exceeding 250 °C and 300 °C respectively between 20 min and 60 min after commencement of test	No Failure	
Crib class	A	Peak heat flux
		40 kW m⁻²
Test Result	BAL: A40	
In addition to the requirements in Section 6 the results of this test are applicable to the tested system being installed near ground level or adjacent to horizontal surfaces.

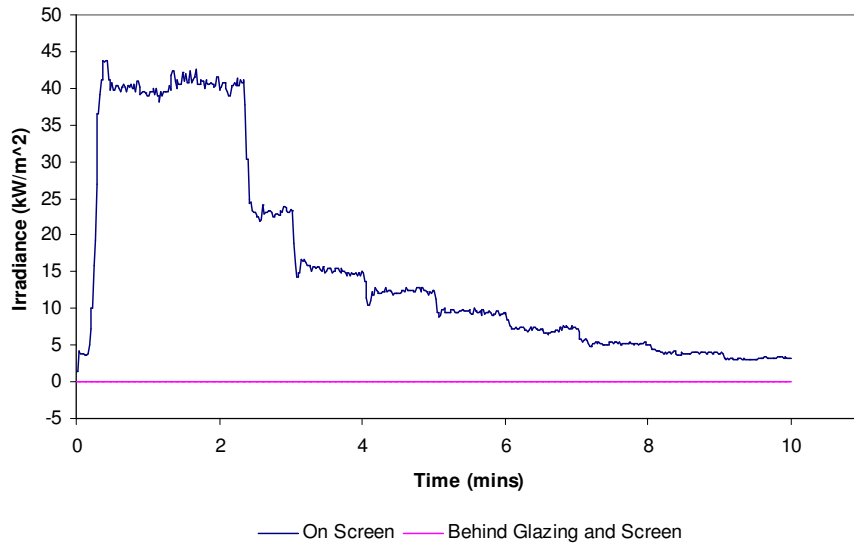
Figure A3.2. Radiant heat exposure profile and irradiance calculated for a distance of 365mm away from unexposed face of Specimen R.

Performance Criteria		Time to Failure (min)	Position of Failure
Formation of through-gaps greater than 3 mm		No Failure	
Sustained flaming for 10 s on the non-fire side		No Failure	
Flaming on the fire-exposed side at the end of the 60 minute test period.		No Failure	
Radiant heat flux 365mm from the non-fire side exceeding 15 kW m ⁻²		No Failure	
Mean and maximum temperature rises greater than 140K and 180K		Not Applicable	
Radiant heat flux 250 mm from the specimen, greater than 3 kW m ⁻² between 20 min and 60 min		No Failure	
Mean and maximum temperature of internal faces exceeding 250 °C and 300 °C respectively between 20 min and 60 min after commencement of test		No Failure	
Crib class	None Applied	Peak heat flux	40 kW m⁻²
Test Result		BAL: -/40	
In addition to the requirements in Section 6 the results of this test are applicable to the tested system being installed at a minimum height of 500 mm above ground level or adjacent horizontal surfaces.

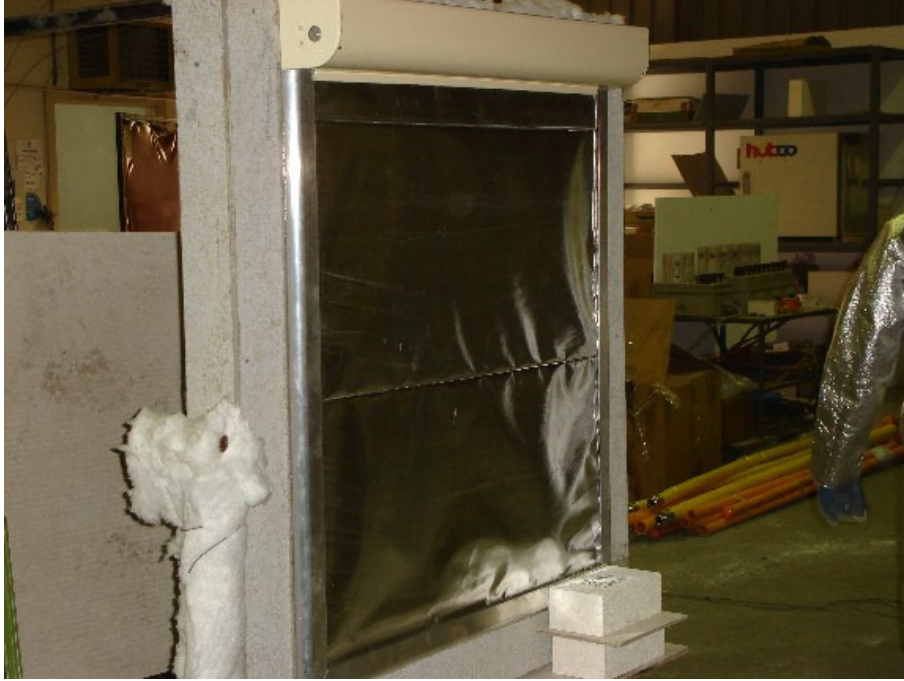
Figure A5.1 Specimen F before commencement of exposure to radiant heat.

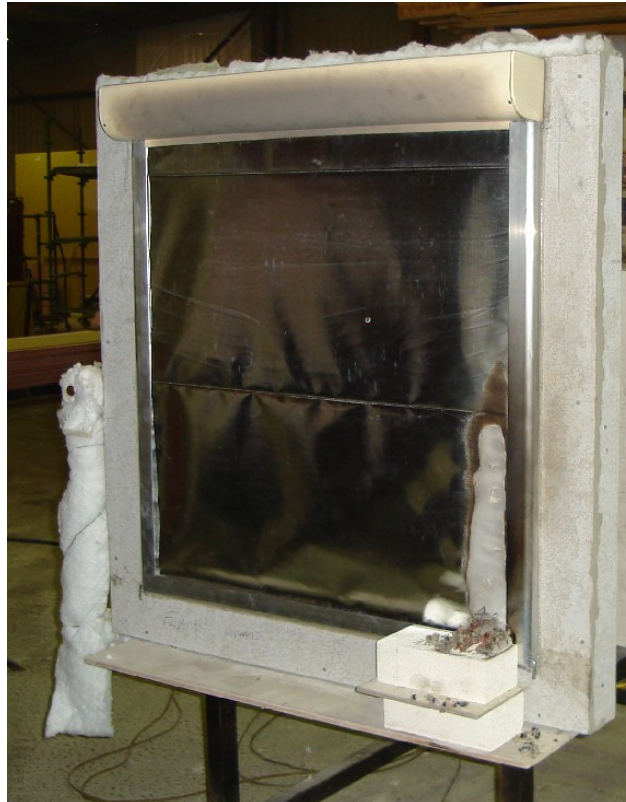
Figure A5.2: Specimen F after exposure to radiant heat and placement of crib.

Time		Observation
Minutes	Seconds	
Specimen F		
0	00	Crib ignited and placed upon sill, adjacent to the specimen which was then exposed to radiant panel.
1	39	Heavy grey smoke observed emanating from the pelmet.
10	00	At the end of the radiant exposure the glazing and screen were intact with some scorch marks apparent on the aluminized screen, adjacent to crib location.
60	00	No gaps have formed in the assembly nor was there any ignition of the exposed face.
60	05	Test terminated.
Specimen R		
0	00	Specimen exposed to radiant panel.
2	07	Heavy grey smoke observed emanating from the pelmet.
2	39	Some discolouration of the paint on pelmet occurred.
10	00	At the end of the radiant panel test the glazing and screen were intact.
60	00	No gaps have formed in the assembly nor was there any ignition of the exposed face.
60	05	Test terminated.

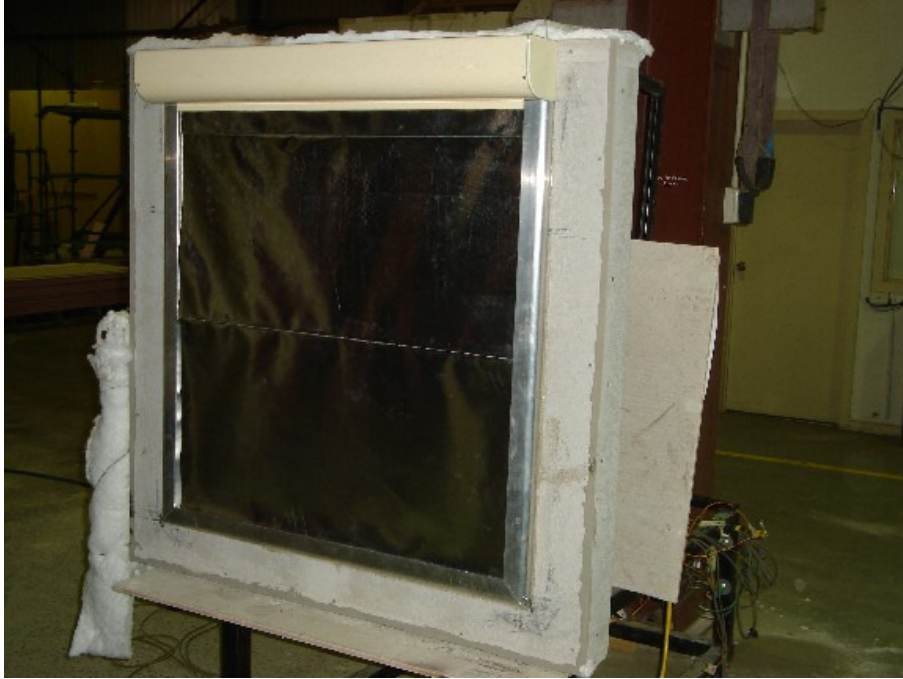
Figure A5.3: Specimen R before commencement of exposure to radiant heat.

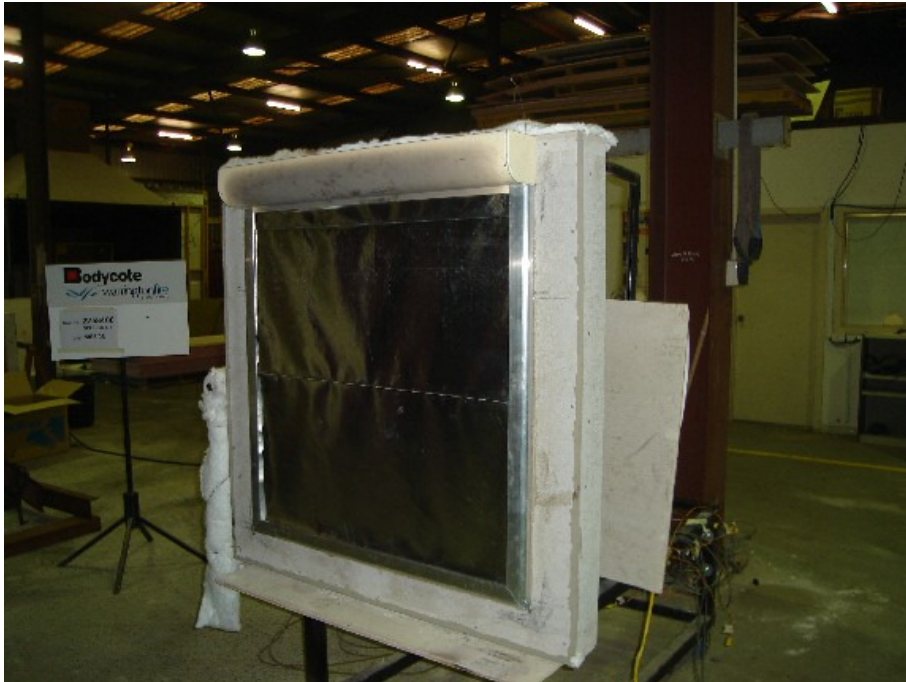
Figure A5.4: Specimen R after exposure to radiant heat.
